# NASA Technical Memorandum 86279

LIGHTNING SWEPT-STROKE ATTACHMENT PATTERNS AND FLIGHT CONDITIONS FOR STORM HAZARDS '81

BRUCE D. FISHER

AUGUST 1984

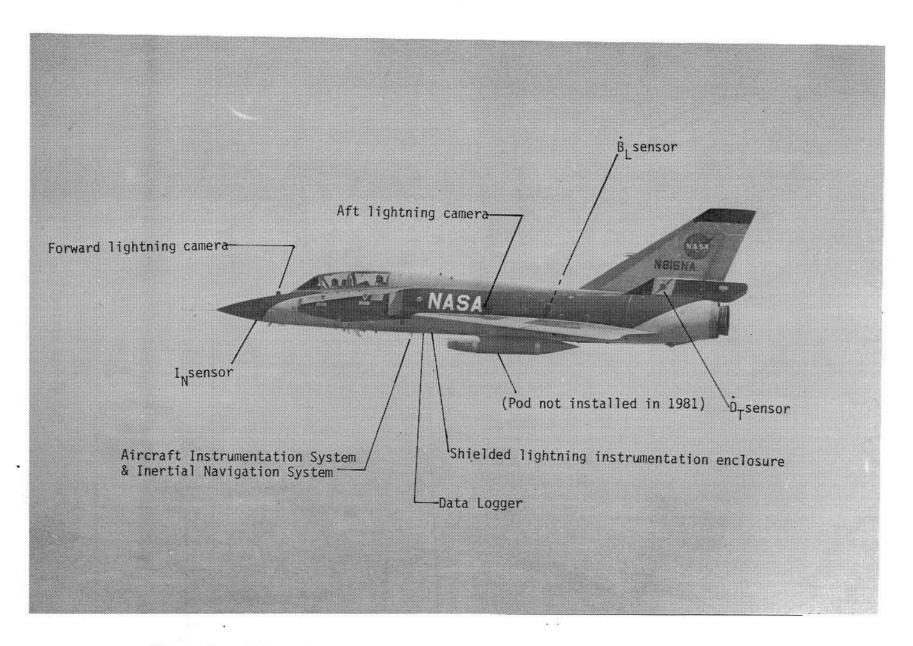
Figure 1.- NASA Langley Research Center Storm Hazards '81 research vehicle.

F-106B research airplane. A thoroughly instrumented F-106B "Delta Dart" airplane (fig. 1) is used to make thunderstorm penetrations in the Storm Hazards Program. Details on the F-106B airplane and the criteria used in choosing the airplane for this mission can be found in references 2, 3, and 7. The lightning hardening procedures and verification tests undertaken prior to each thunderstorm season are described in references 2 and 7.

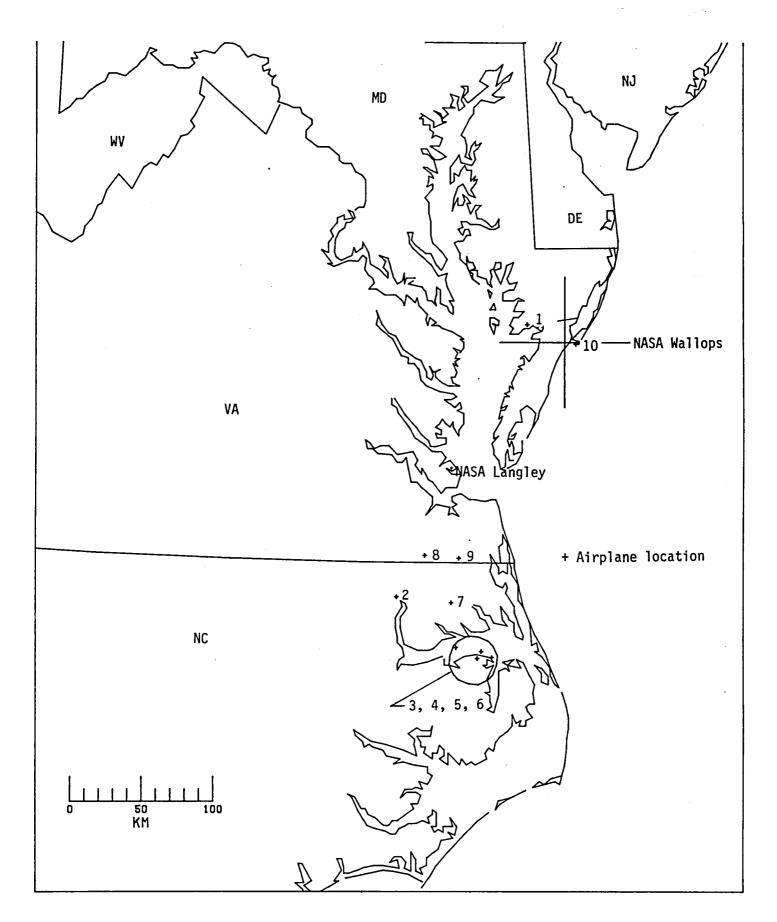
Figure 2.- Location of airplane at time of each lightning event in 1981.

(a) Direct strikes.

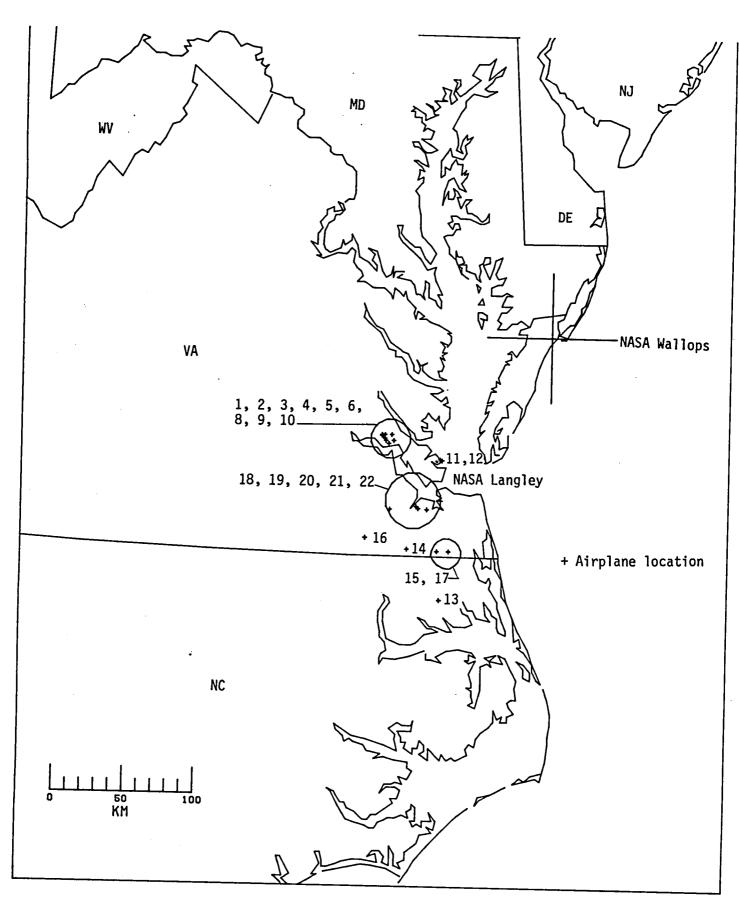
Figure 2.- Concluded.

(b) Nearby flashes.

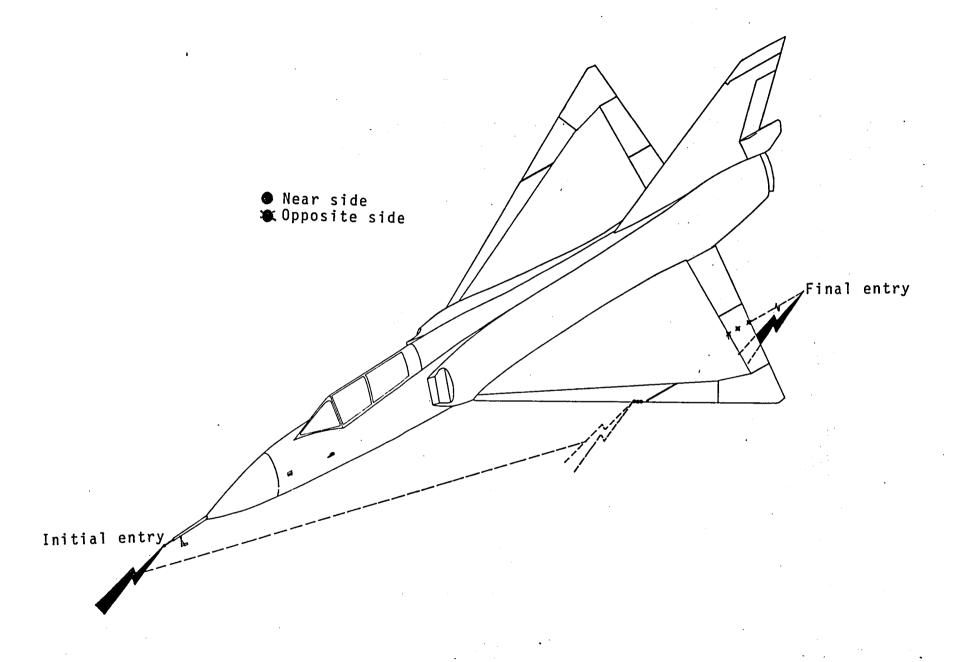
- 2. Similar to (1) except that the entry channel sweeps aft across the top or bottom wing surface instead of the fuselage. Three strikes meet this description, including strike 1 of 1981 (figs. 3 and 4), in which the channel swept back over the leading edge of the wing to the lower surface of the elevon with no apparent attachment points in the midspan area.

Figure 3.- Lightning attachment points and scenario for strike 1 of 1981, Flight 81-036, July 21, 1981. (Exit location unknown)

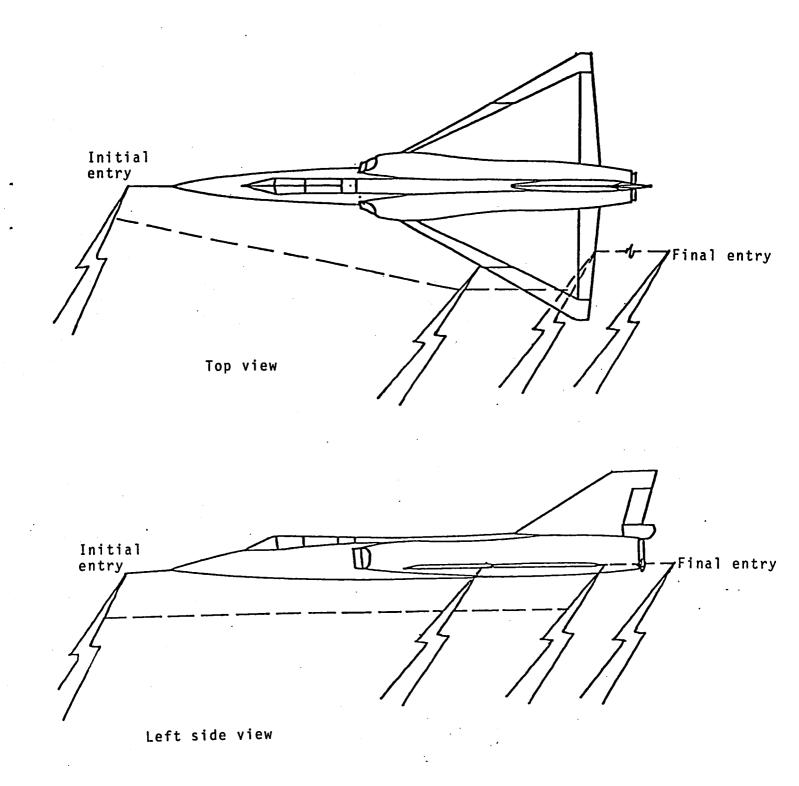
Figure 4.- Lightning strike scenario for strike 1 of 1981, Flight 81-036, July 21, 1981. (Exit location unknown.)

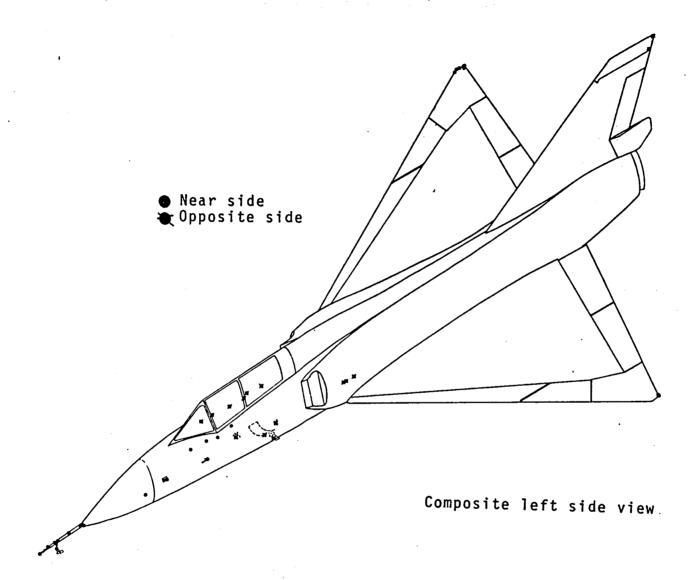
Figure 5.- Lightning attachment points for strikes 2-6 of 1981, Flights 81-039 and 81-040, July 29, 1981.

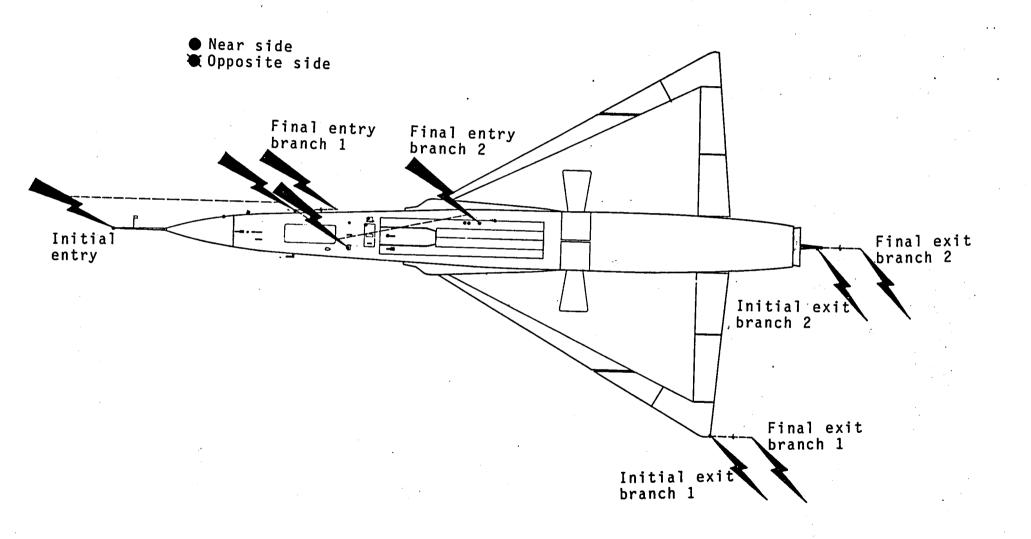
Figure 6.- Lightning attachment points and scenario for strike 2 of 1981, Flight 81-039, July 29,1981. Bottom view.

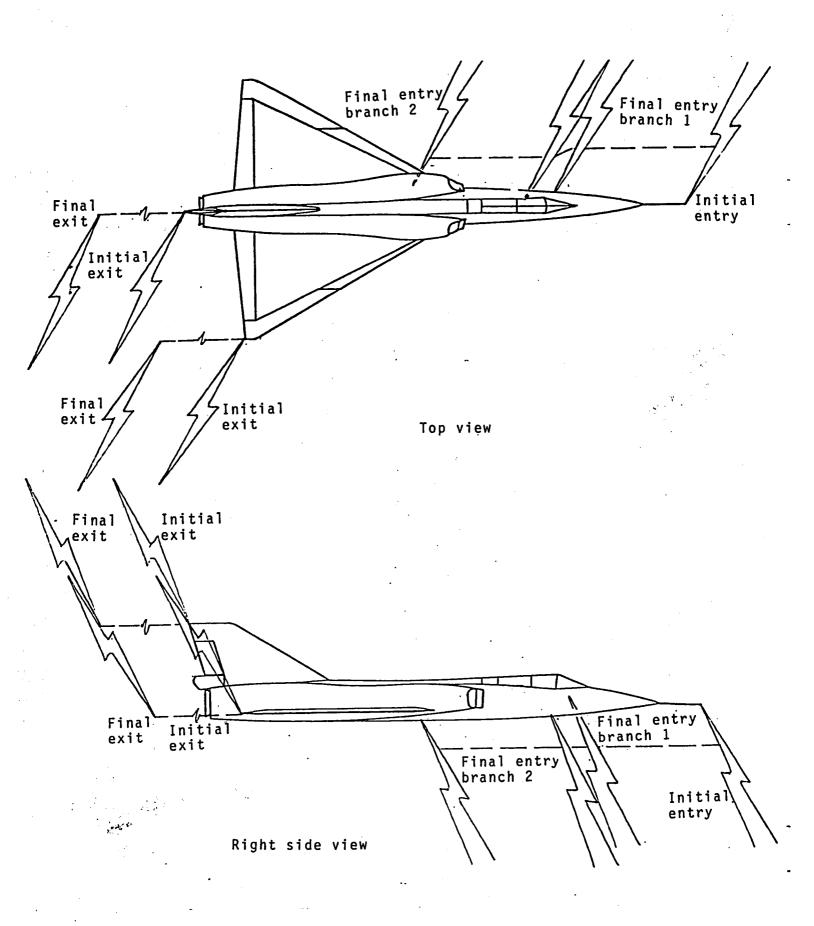
Figure 7.- Lightning strike scenario for strike 2 of 1981, Flight 81-039, July 29, 1981.

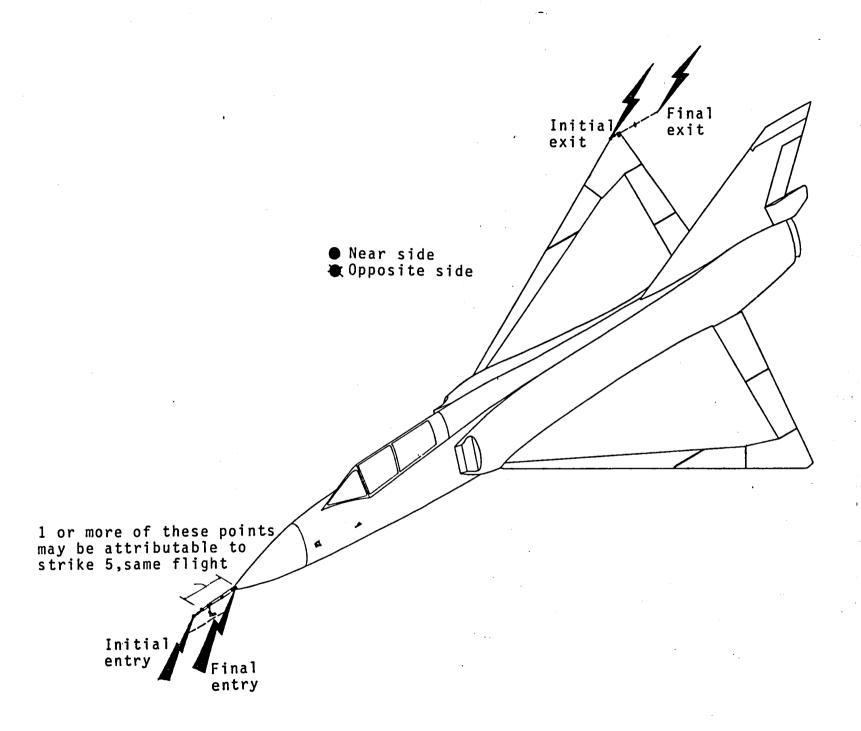
Figure 8.- Lightning attachment points and scenario for strike 3 of 1981, Flight 81-040, July 29, 1981.

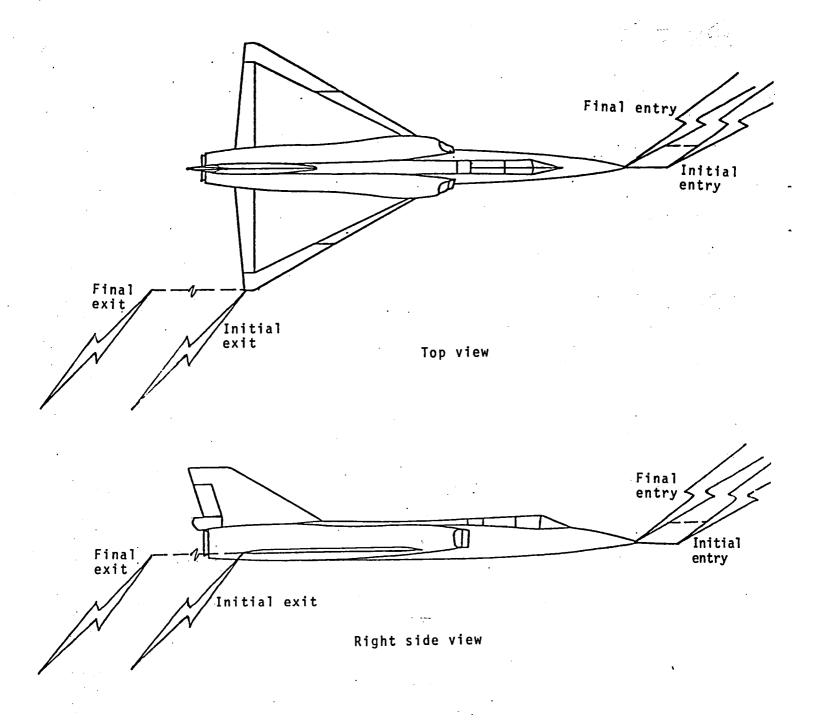
Figure 9.- Lightning strike scenario for strike 3 of 1981, Flight 81-040, July 29,1981.

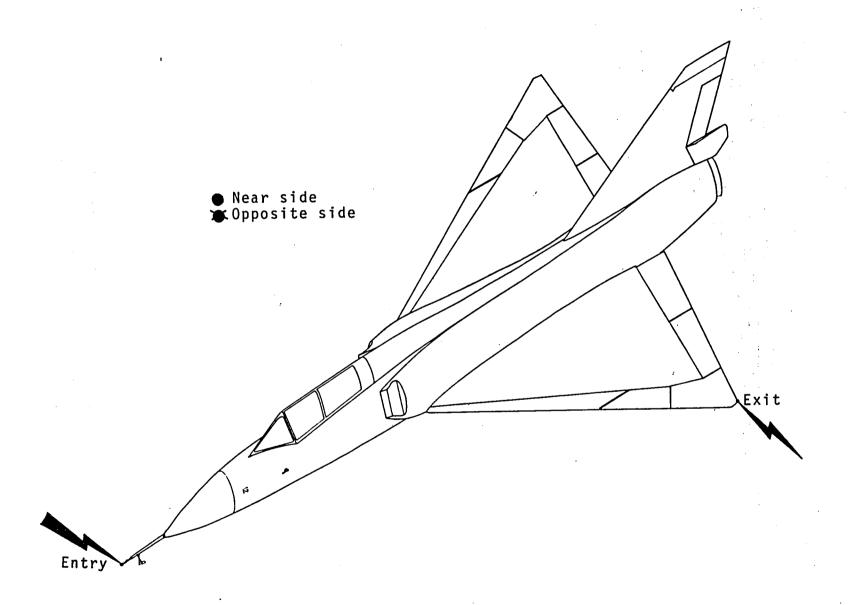
Figure 10.- Lightning attachment points and scenario for strike 4 of 1981, Flight 81-040, July 29, 1981.

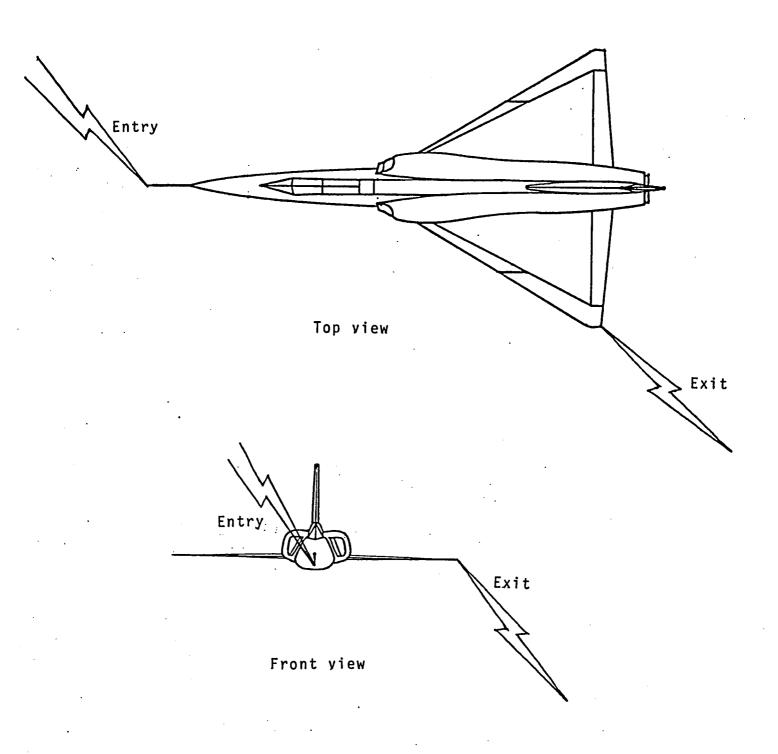
Figure 11.- Lightning strike scenario for strike 4 of 1981, Flight 81-040, July 29, 1981.

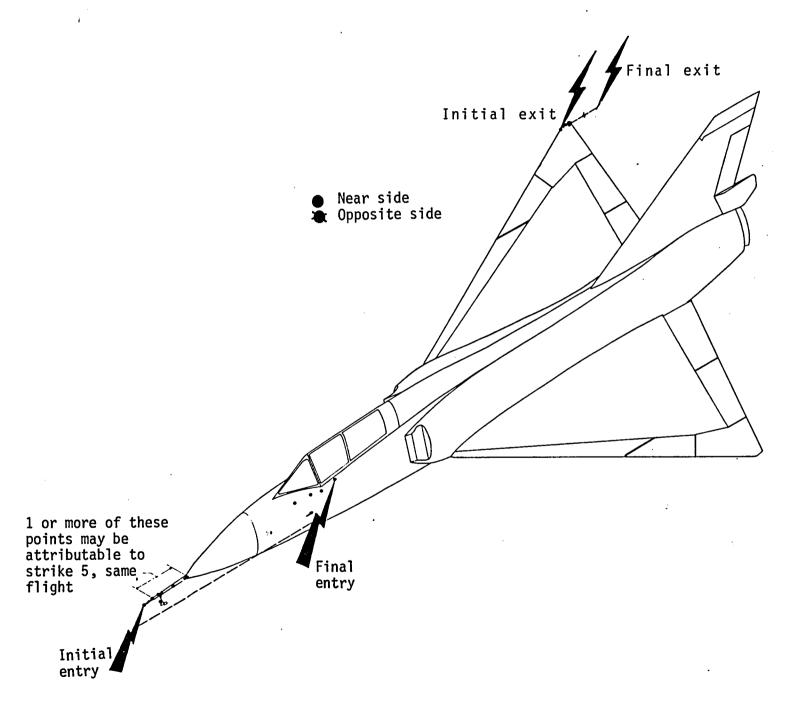
Figure 12.- Lightning attachment points and scenario for strike 5 of 1981, Flight 81- 040, July 29, 1981.

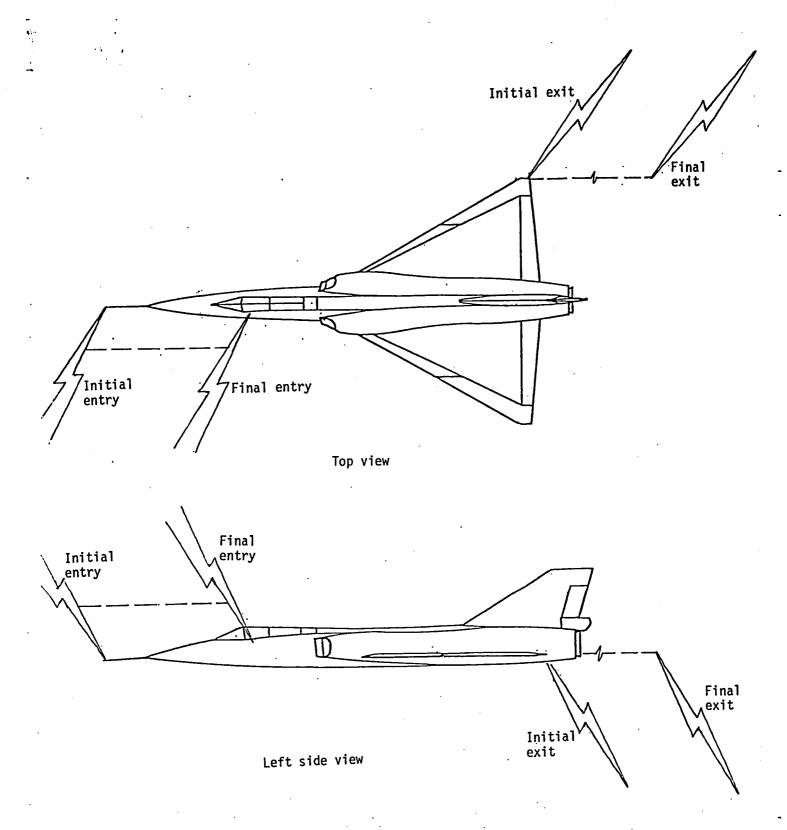
Figure 13.- Lightning strike scenario for strike 5 of 1981, Flight 81-040, July 29,1981.

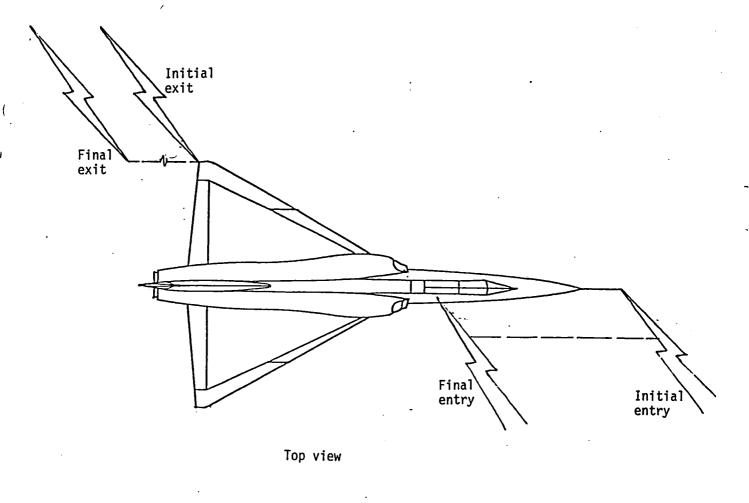
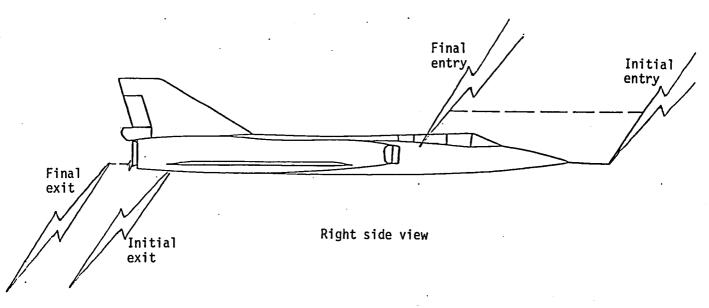
Figure 15.- Lightning strike scenario for strike 6 of 1981, Flight 81-040, July 29, 1981.

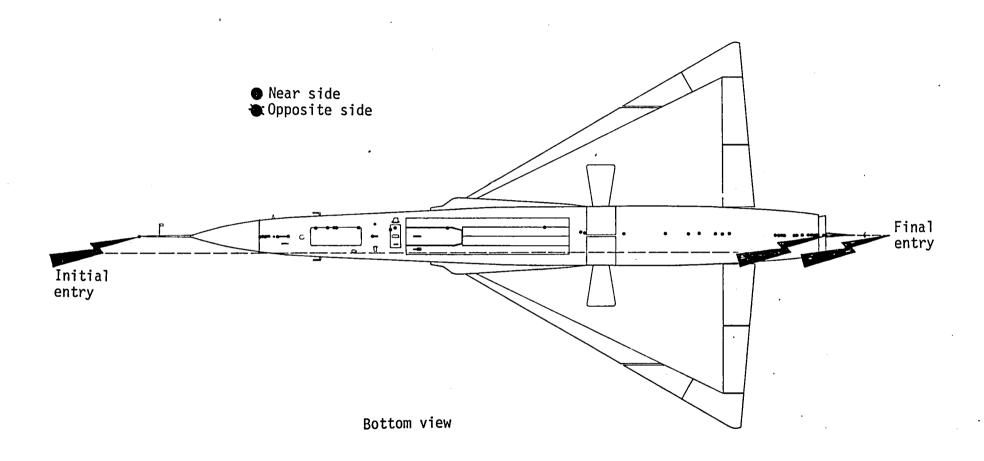
Figure 16.- Lightning attachment points and scenario for strike 7 of 1981, Flight 81-042, August 11, 1981.

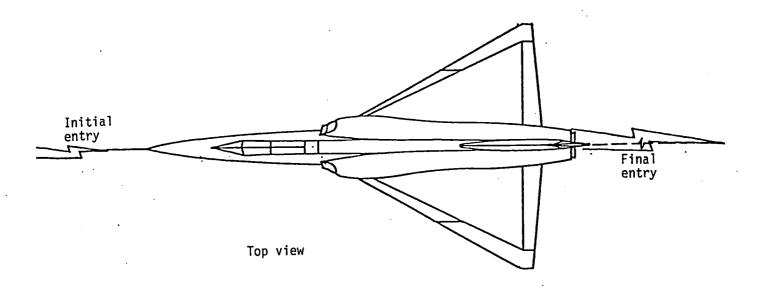
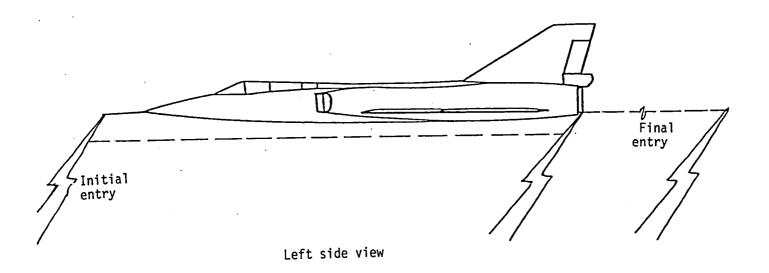
Figure 17.- Lightning strike scenario for strike 7 of 1981, Flight 81-042, August 11, 1981. (Exit location unknown.)

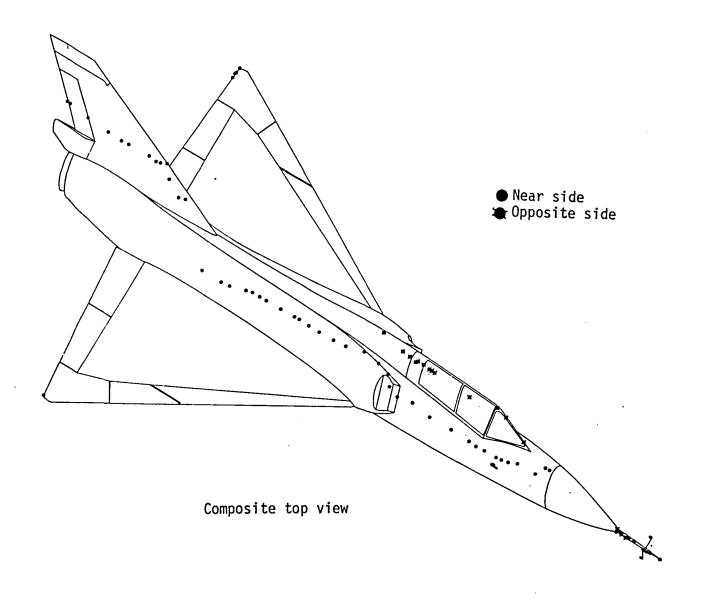
Figure 18.- Lightning attachment points for strikes 8 and 9 of 1981, Flight 81-043, August 16, 1981.

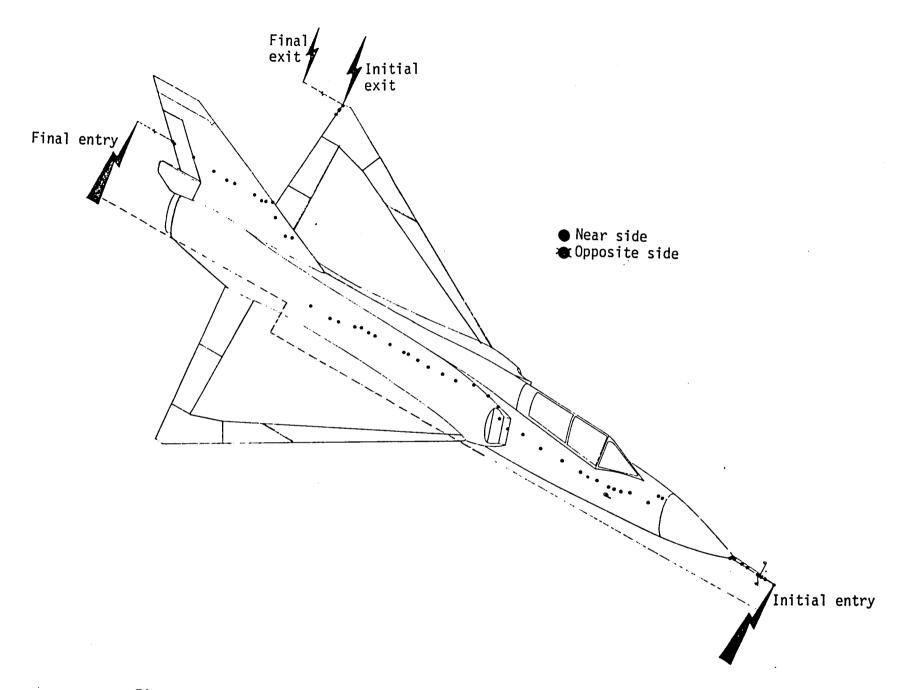
Figure 19.- Lightning attachment points and scenario for strike 8 of 1981, Flight 81-043, August 16, 1981.

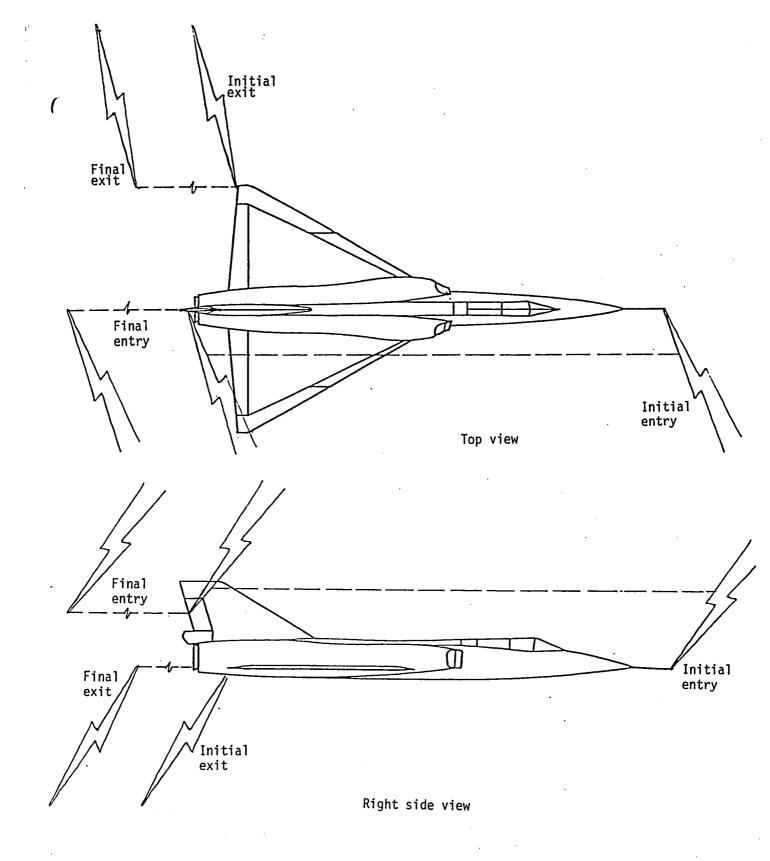
Figure 20.- Lightning strike scenario for strike 8 of 1981, Flight 81-043, August 16, 1981.

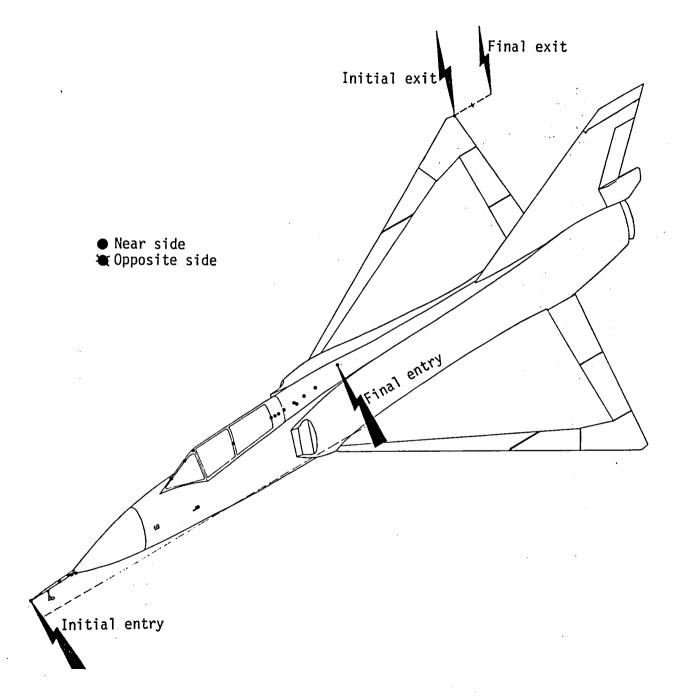
Figure 21.- Lightning attachment points and scenario for strike 9 of 1981, Flight 81-043, August 16,1981.

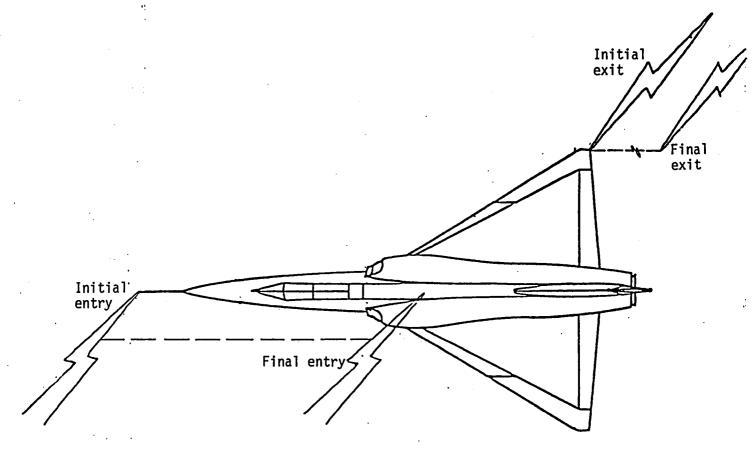
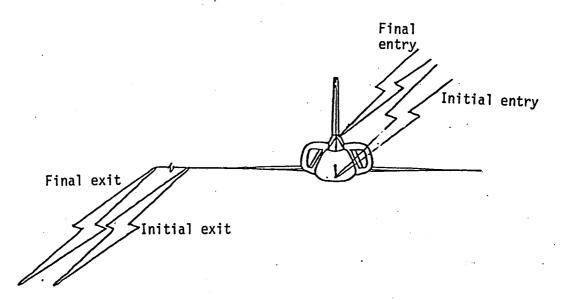
Figure 22.- Lightning strike scenario for strike 9 of 1981, Flight 81-043, August 16, 1981.

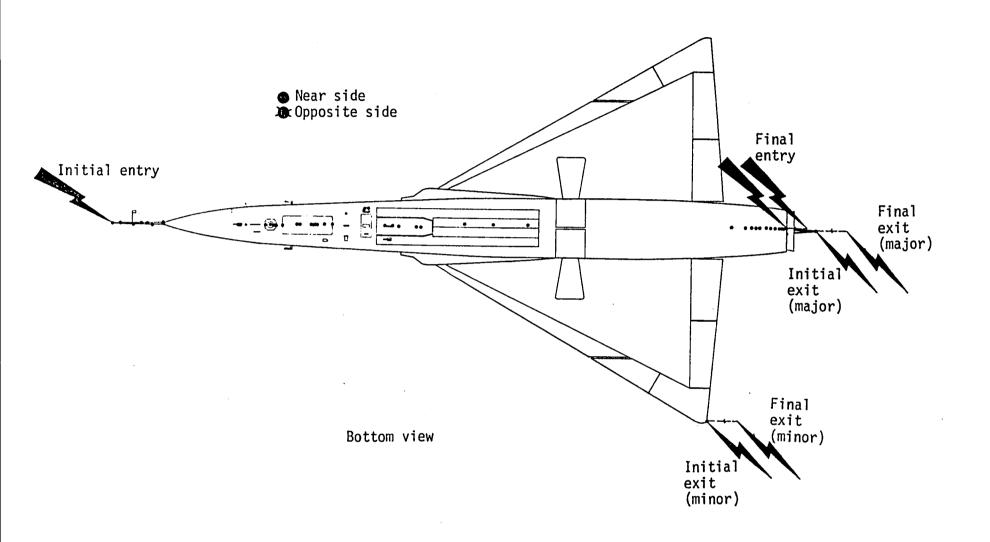
Figure 23.- Lightning attachment points for strike 10 of 1981, Flight 81-046, September 8,1981.

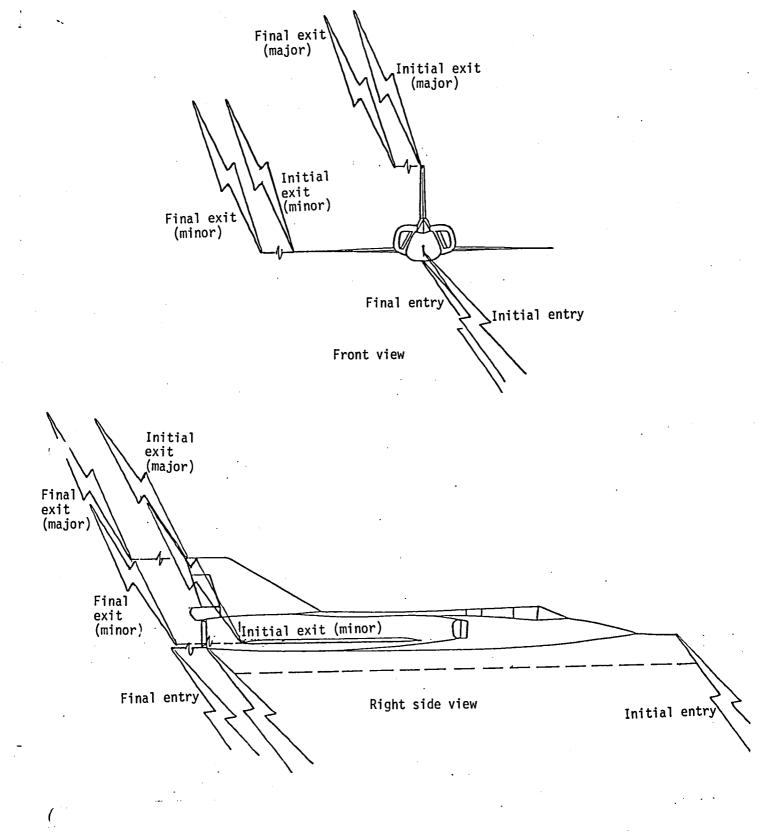
Figure 24.- Lightning strike scenario for strike 10 of 1981, Flight 81-046, September 8, 1981.
